DESIGN AND CONSTRUCTION OF
TEST FACILITIES TO SIMULATE THE EFFECTS
OF A NUCLEAR DETONATION
HANDEC I AND HANDEC II

The Bob Rutherford Construction Company

TECHNICAL REPORT NO. AFWL-TR-69-171

May 1970

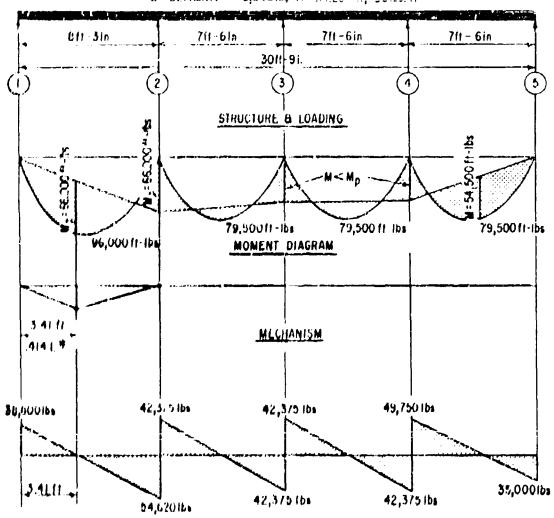
$w = 2,260 \text{ ibs/ft} \times 4 \text{ ft 0 C} = 9,040 \text{ ibs/ft}$   $W = ULTIMAT( = 9,040 \text{ ibs/ft} \times 1.25 = 11,200 \text{ ibs/ft}$

WHILLERENCE "PLASTIC DESIGN OF STEEL BY L. DELDLE.

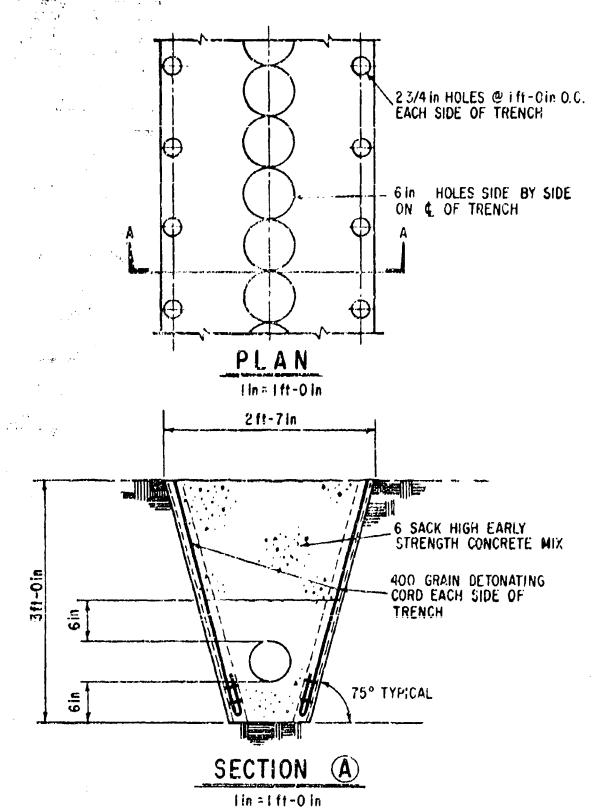
Figure 2. Typical Trench Blasting Method for HANDEC 11

Numerous tests were conducted to determine the hest method for blasting instrumentatic trenches. After experimentation at the Cedar City test site, the contractor found that 400 grain detonating cord spaced in 2 3/4 inch holes on 1 foot centers each side of trenches produced the best method for trench excavation. (Corps of Engineers drilled the centerline of these trenches with 6-inch relief holes, side by side.) See Figure 2.

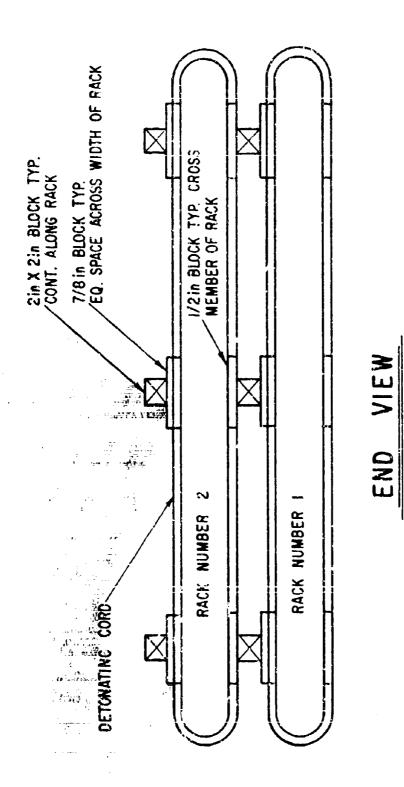
Figure 3. Typical Rack Support for HANDEC I

- 6. Detonating cord rack supports for HANDEC I (see Figure 75) were redesigned by the contractor for better structural support. Dowels and 2 by 2 inch lumber were eliminated, thereby requiring fewer piece parts and less labor during assembly. (See Figure 3.)

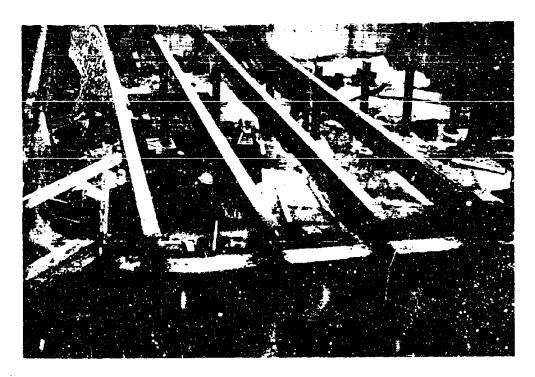
Figure 19. HANDEC I Test Ped, Showing Concrete Walls, Beams, Columns and Test Model Locations.

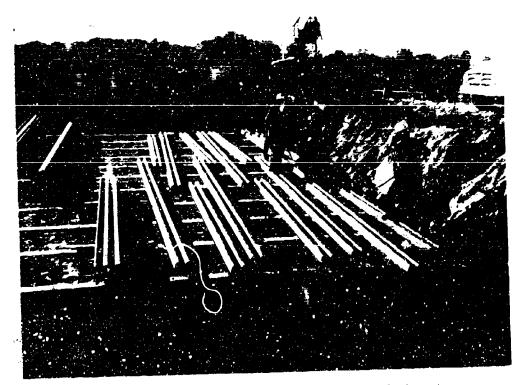
Figure 27. Earth Fill Between Steel Beams Prior to Structural Steel Deck Installation, HANDEC I.

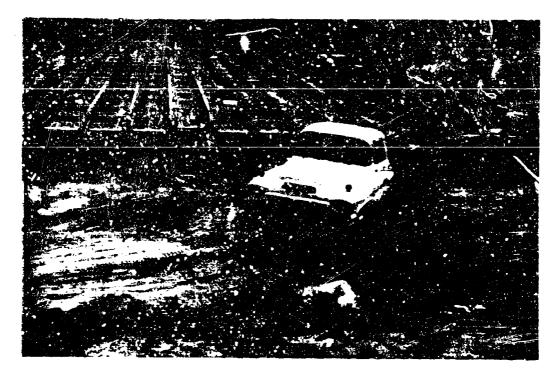
Figure 59. HANDEC II Test Bed. Beams Placed over Detonating Cord Prior to Erection of Subdeck and Decking.

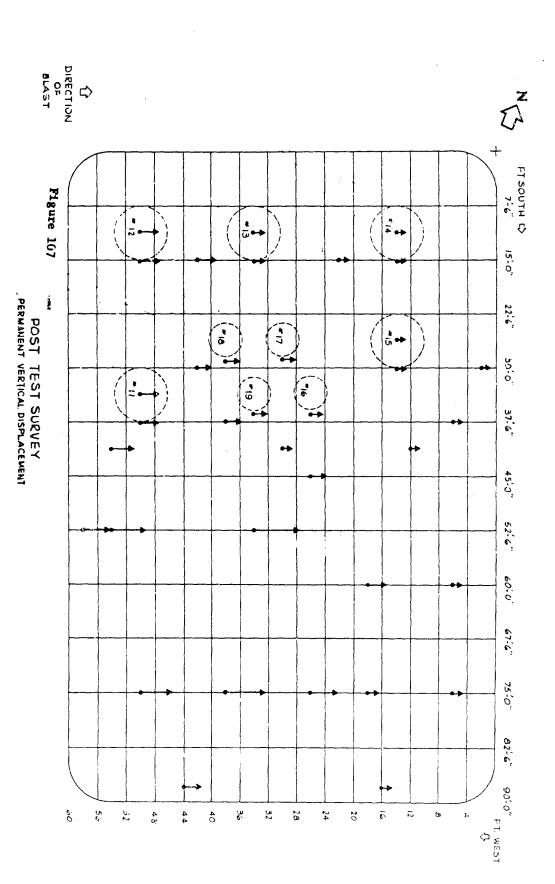
COLUMN GRID LINES ---- 1": 5'-0"

\*See Figure 107
\*\*First digit denotes column row number from north to south
Last two digits denote column number from east to west
